# **Masat e EE dhe Implementimi - Programi i trajnimit për Kompanitë Ndërtimore dhe Inxhinierët e Mbikëqyrjes**

**Rezultatet e analizave të ndërtesave publike dhe  
masat tipike të indentifikuara**

Zlatko Bačelić Medić  
z.bacelic@ic-group.org  
10/11/2016

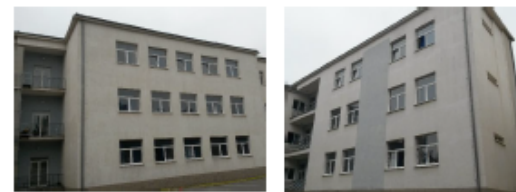
Figure 6 - Walls

Building was constructed during 1936, structurally it consists of walls made out of full brick and concrete with a thickness of 33 cm and plaster from both sides. Outside walls are assessed to be in quite a good condition from the structural point of view with some minor damages in plaster. It is recommended to install the thermal insulation on the facade but minor damages have to be treated prior to EPS installation.

The existing layers are presented in Table 3. Existing wall can be seen in photos, Figure 6.

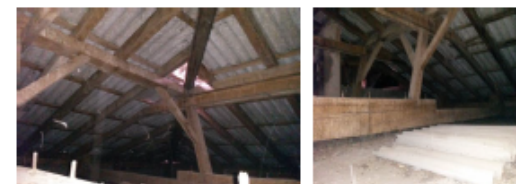
Figure 8 – Roof

According to the visual inspection, the roof has a solid wooden structure forming a regular geometric shape. Roof is assessed to be structurally sound. However, it is covered with asbestos corrugated plates which need to be removed and handled carefully by professionals. New covering should include wooden planks, vapor barrier and metallic corrugated sheets. It is recommended to install thermal insulation on the roof with a rock wool layer to be laid on the slab and covered with a protective layer of screed, but only after construction works are completed.
